Manhole Inspection Summary

Manhole # S09EE2021MH

Insp Date: **7/31/06 1:24 PM**

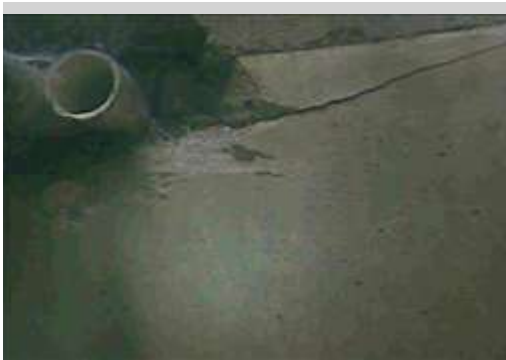
Defect

Barrel Material: **Precast Concrete** ☐ Parged
Shape: **Circular** Diameter: **48** (in.) Length: (in.)
Condition: ☐ Sound ☒ **Cracked** ☐ Root Intrusion ☐ Loose Brick ☐ Deteriorated
Infiltration: ☐ None ☒ **Joint** ☒ **Cracks** ☒ **Mortar** ☐ Roots ☐ Wall

cracks in barrel

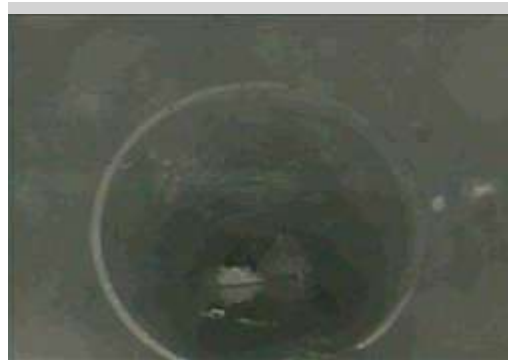
Defect

debris in outlet

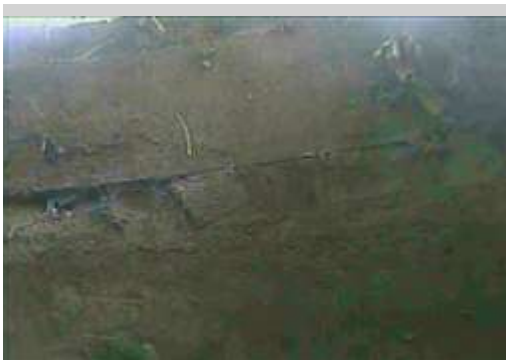
Defect

Corbel Material: **Precast Concrete** ☐ Parged Type: **Concentric/Eccentric**
Condition: ☒ Sound ☐ Cracked ☐ Root Intrusion ☐ Loose Brick ☐ Deteriorated
Infiltration: ☐ None ☒ **Joint** ☐ Cracks ☐ Mortar ☐ Roots ☐ Wall

infiltration in corbel/frame

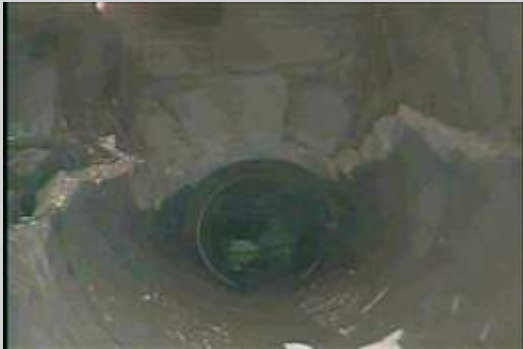
8 in. Circular Gravity Sewer Pipe Out @ 12 O'Clock

Deposits: ☐ None ☐ Mud ☐ Sludge ☒ **Debris** ☐ Grease

Silt Depth: **1** (in.) Deposits Extent: **Light**
